Reference No. SMS1.20294-L6.Rev0

LOT 787 PHILLIP AVENUE, ANGLE VALE – MIRAVALLE STAGE 1

T&J CONSTRUCTIONS
MIRAVALE STAGE 1
ANGLE VALE
SITE PLAN

POST-FILL LEVEL SURVEY MIRAVALE SOUTH, STAGE 1 ANGLE VALE	
DRAWING No.	SHEET 1 OF 1
20A0478.C0001 Miravale South Stage 1 Post Fill Rev 0	
REVISION	0

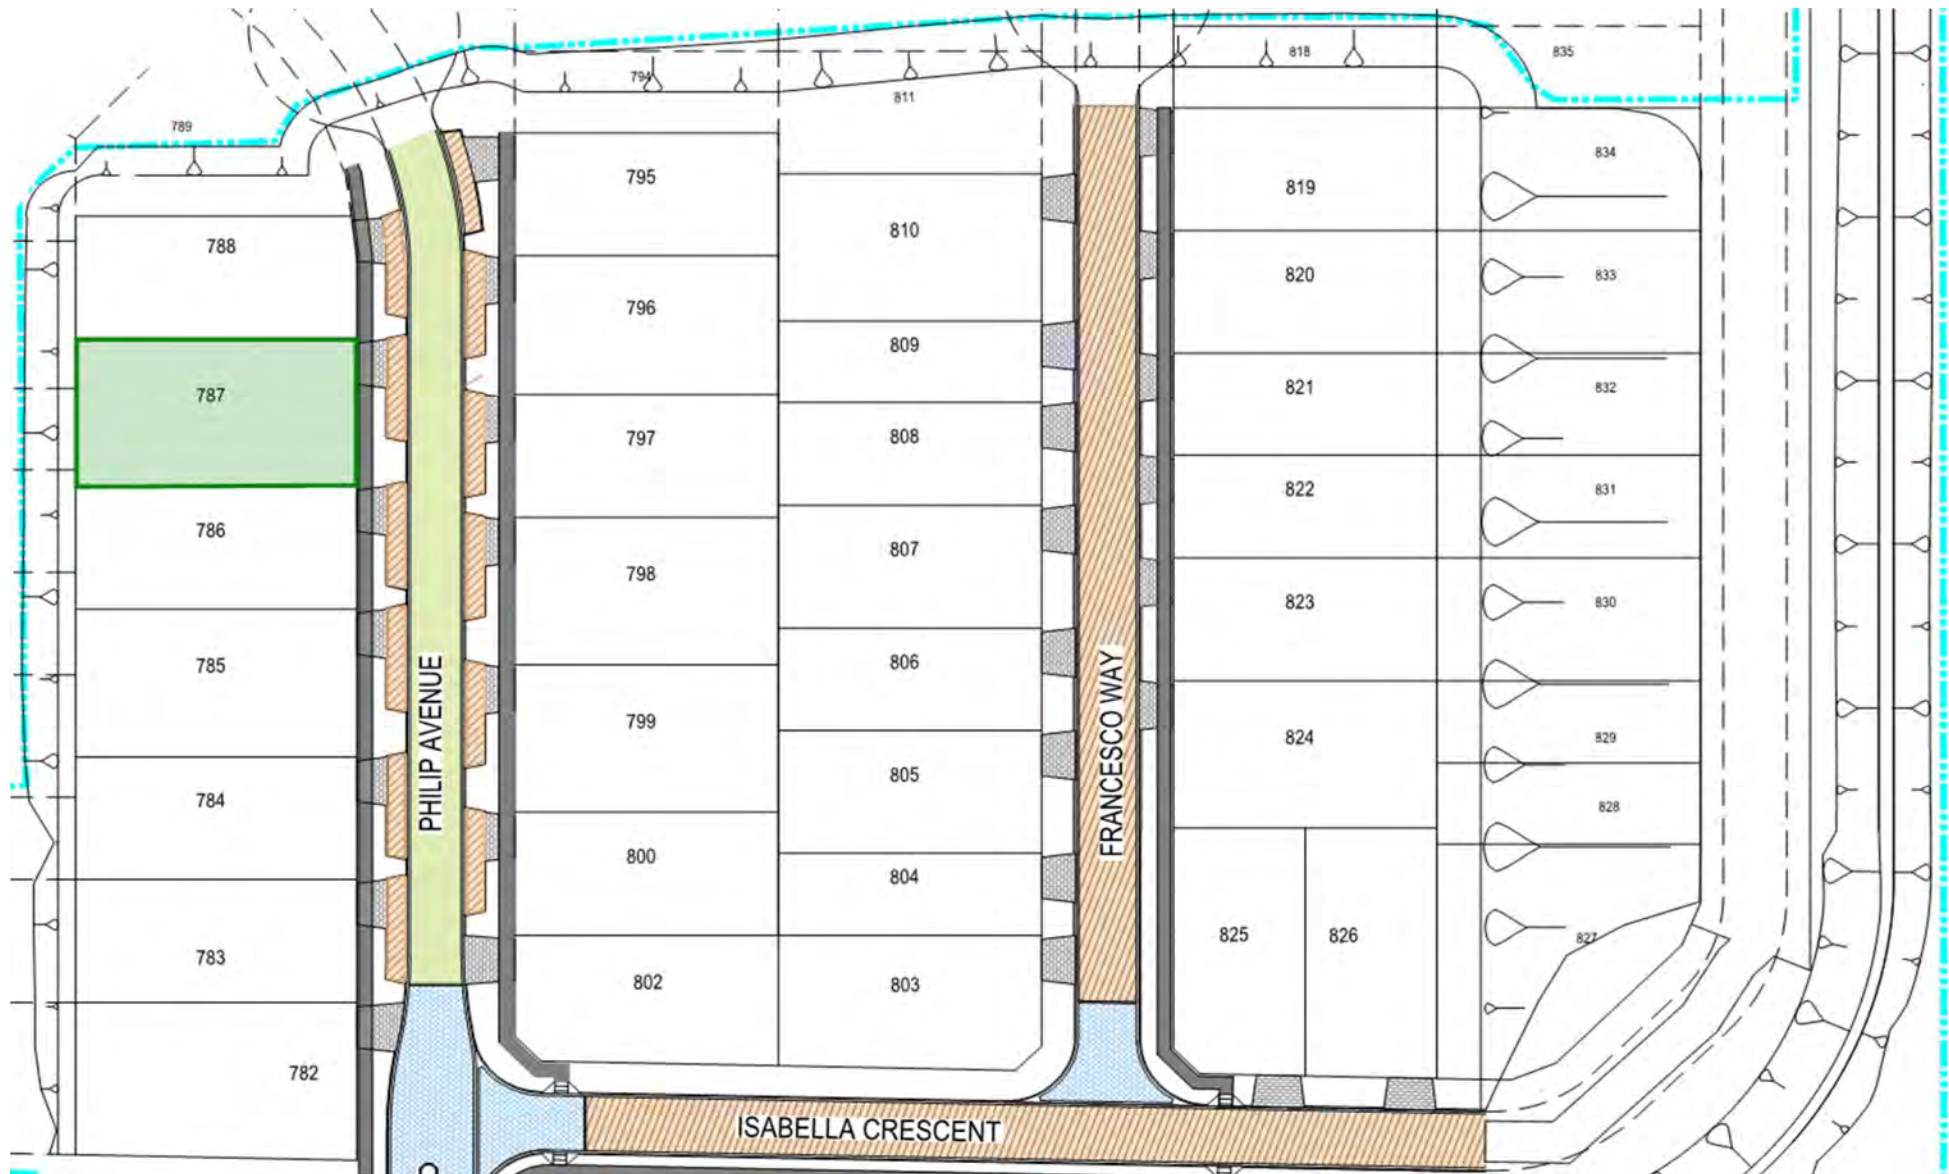
Project No.:	SMS1.20294	Drawing No.:	SMS1.20294-F6.Rev0
--------------	-------------------	--------------	---------------------------

SMS Geotechnical Pty Ltd (SMS) was commissioned by T&J Constructions to provide Level 1 earthworks inspection and testing services on Lot 787 Phillip Avenue, South Australia. The area where fill was placed is shown approximately in Drawing SMS1.20294-F6.Rev0.

On the completion of Level 1 earthworks inspection and testing, SMS advise that the fill placed on Lot 787 Phillip Avenue as shown in Drawing SMS1.20294-F6.Rev0, was witnessed and in our opinion meets the requirements of "Controlled Fill" as defined in AS3798-2007 and AS2870-2011 "Residential slabs and footings".

Approx. Fill Location
