Reference No. SMS1.20294-L35.Rev0

LOT 828 ISABELLA CRESCENT, ANGLE VALE – MIRAVALE STAGE 1

T&J CONSTRUCTIONS
MIRAVALE STAGE 1
ANGLE VALE
SITE PLAN

POST-FILL LEVEL SURVEY MIRAVALE SOUTH, STAGE 1 ANGLE VALE	
DRAWING No.	SHEET 1 OF 1
20A0478.C0001 Miravale South Stage 1 Post Fill Rev 0	
REVISION	0

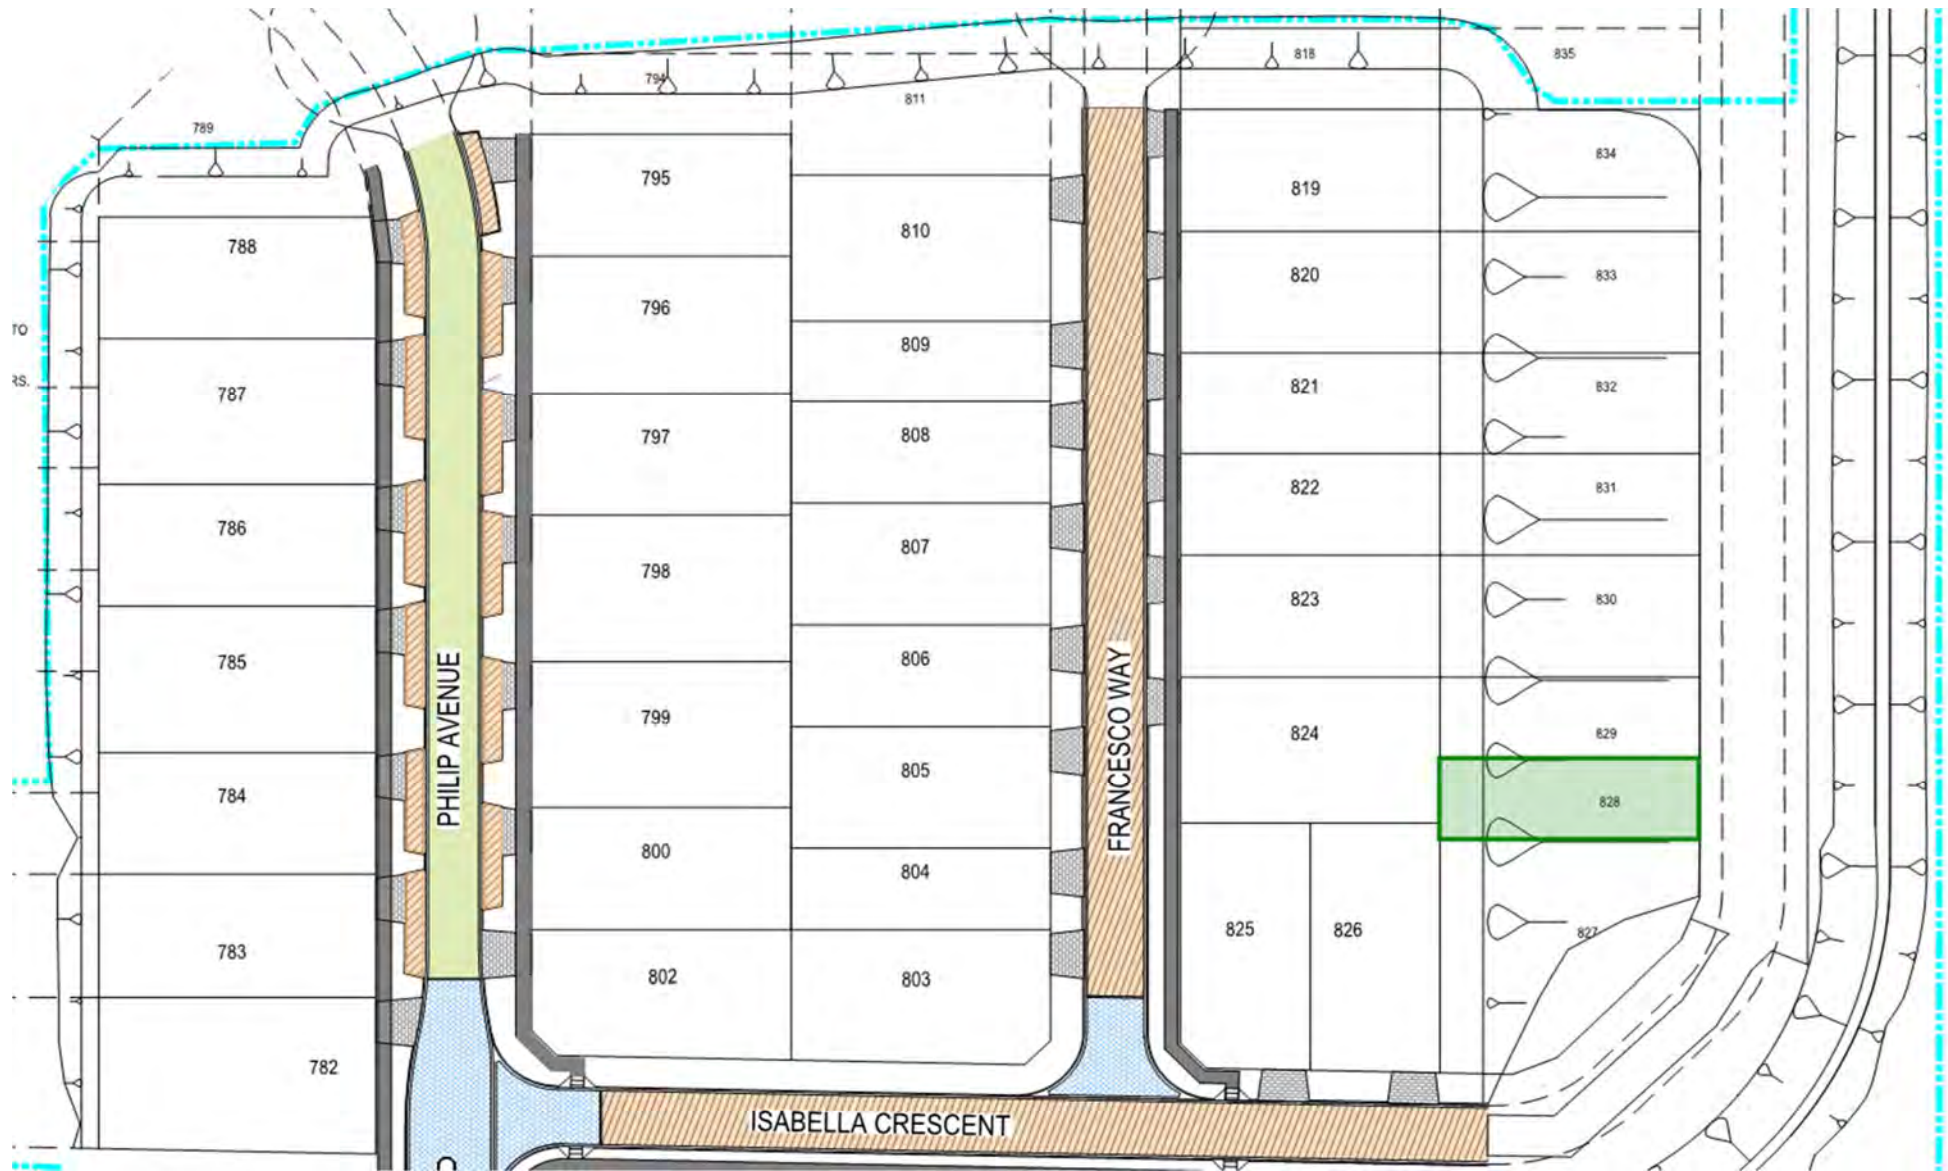
Project No.:	SMS1.20294	Drawing No.:	SMS1.20294-F35.Rev0
--------------	-------------------	--------------	----------------------------

On the completion of Level 1 earthworks inspection and testing, SMS advise that the fill placed on Lot 828 Isabella Crescent as shown in Drawing SMS1.20294-F35.Rev0, was witnessed and in our opinion meets the requirements of "Controlled Fill" as defined in AS3798-2007 and AS2870-2011 "Residential slabs and footings".

Approx. Fill Location
