24<sup>th</sup> November 2020

Reference No. SMS1.20294-L26.Rev0

**LOT 819 FRANCESCO WAY, ANGLE VALE – MIRAVALE STAGE 1**

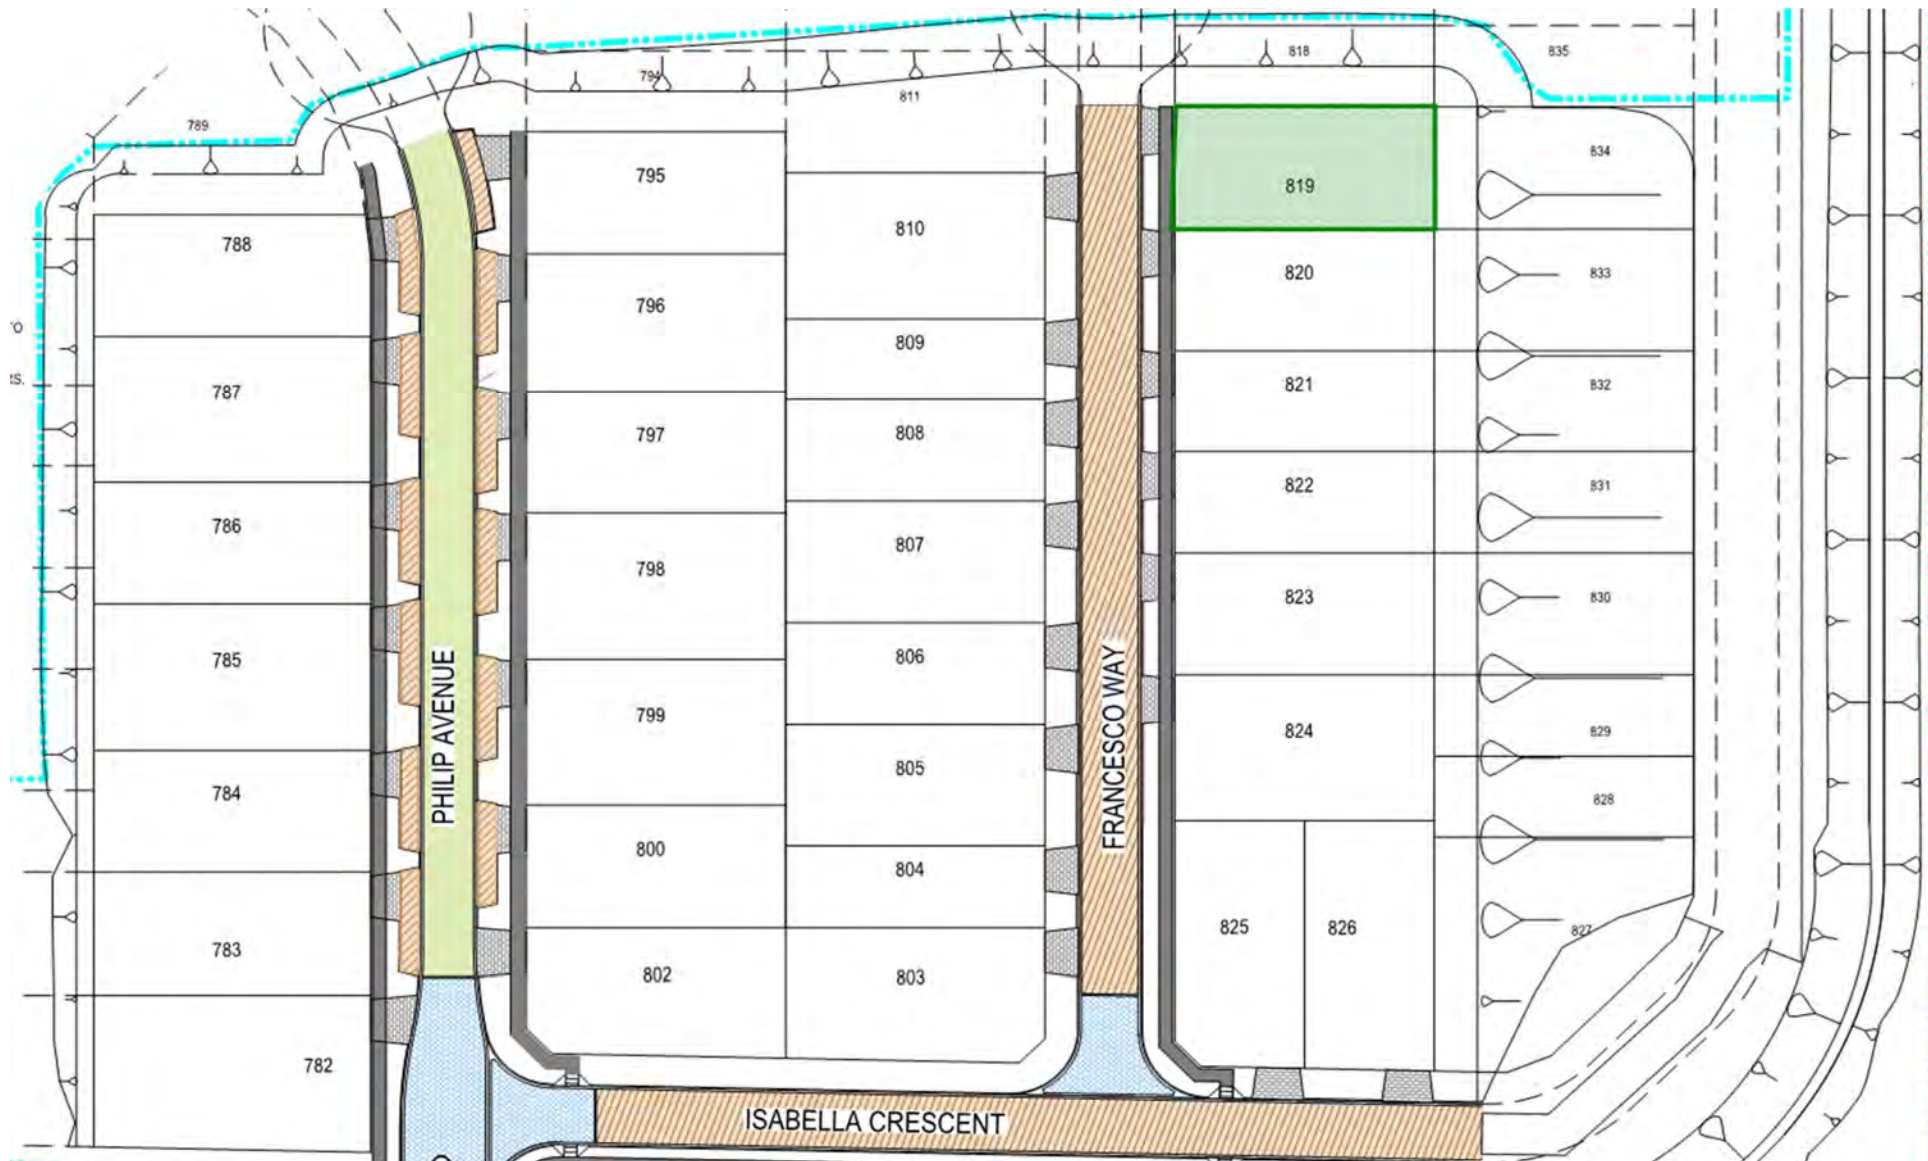
Project No.:	<b>SMS1.20294</b>	Drawing No.:	<b>SMS1.20294-F26.Rev0</b>
--------------	-------------------	--------------	----------------------------

SMS Geotechnical Pty Ltd (SMS) was commissioned by T&J Constructions to provide Level 1 earthworks inspection and testing services on Lot 819 Francesco Way, South Australia. The area where fill was placed is shown approximately in Drawing SMS1.20294-F26.Rev0.

On the completion of Level 1 earthworks inspection and testing, SMS advise that the fill placed on Lot 819 Francesco Way as shown in Drawing SMS1.20294-F26.Rev0, was witnessed and in our opinion meets the requirements of "Controlled Fill" as defined in AS3798-2007 and AS2870-2011 "Residential slabs and footings".

Approx. Fill Location

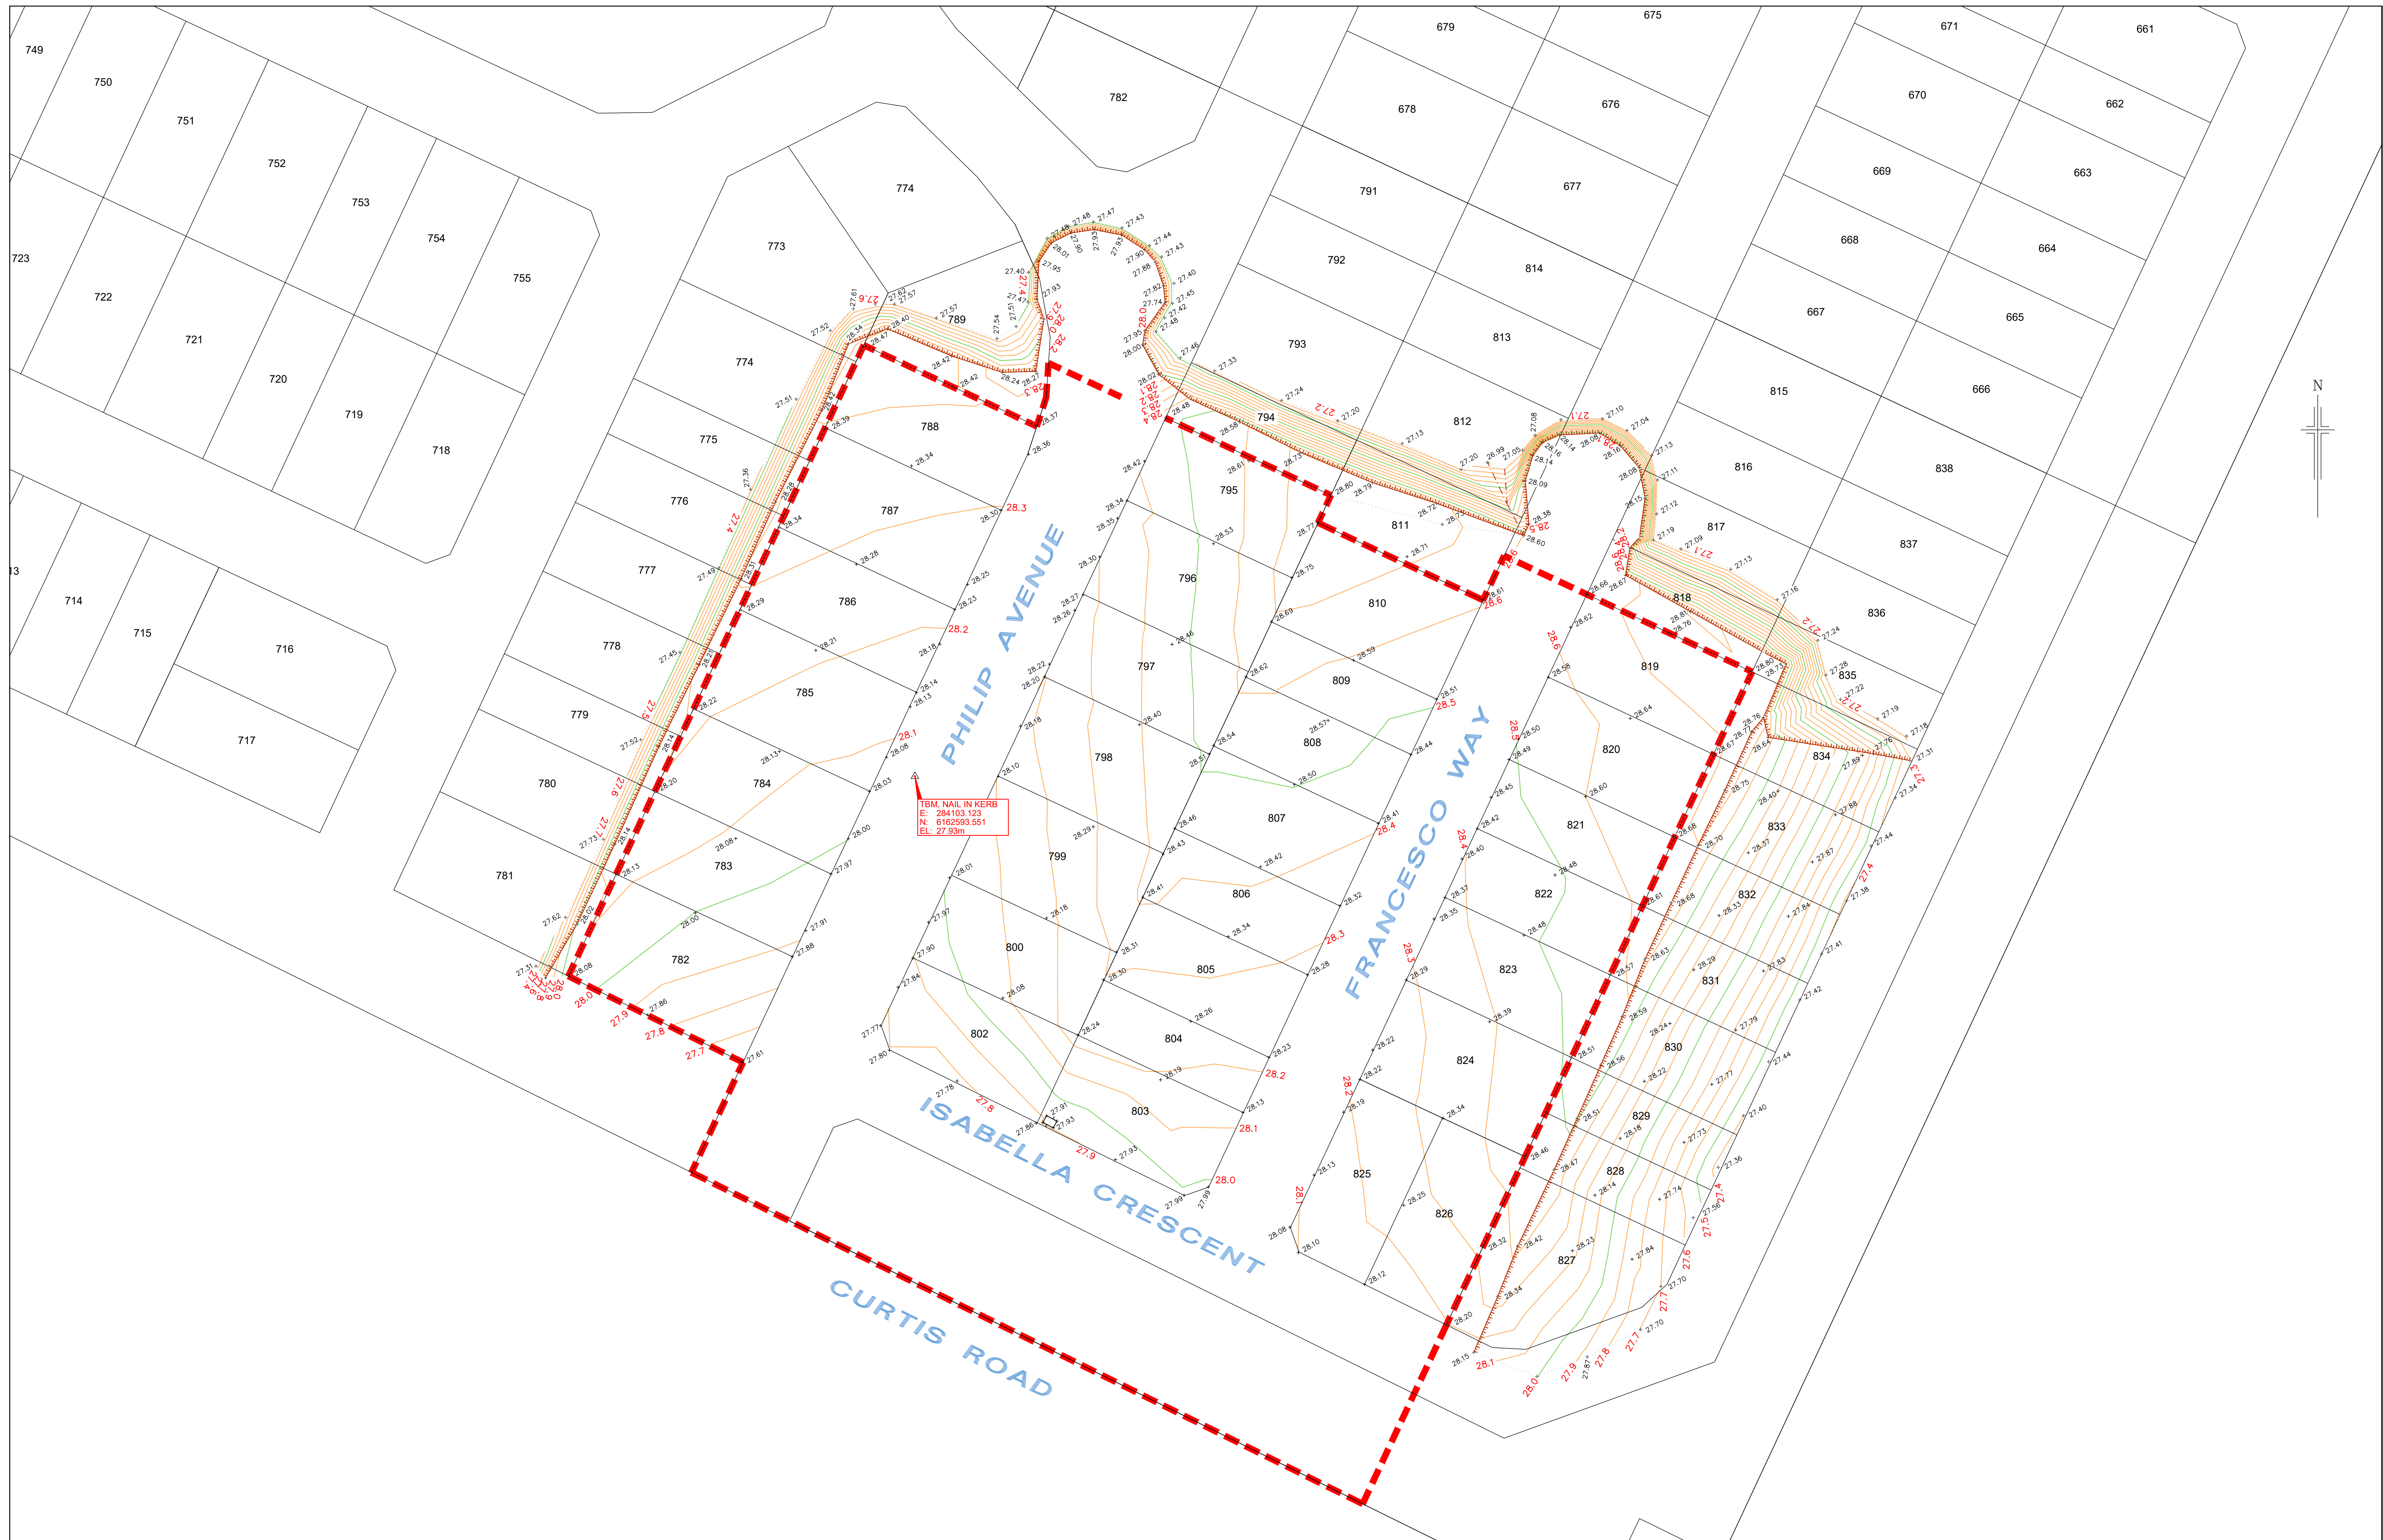
POST-FILL LEVEL SURVEY MIRAVALE SOUTH, STAGE 1 ANGLE VALE	
DRAWING No.	SHEET 1 OF 1
20A0478.C0001 Miravale South Stage 1 Post Fill Rev 0	
REVISION	0

Pre and Post fill levels were undertaken by Alexander Symonds Survey Consultants. These levels are detailed in pre-fill level survey Miravale South, Stage 1 Angle Vale revision A and post-fill level survey Miravale South, Stage 1 Angle Vale revision 0.
