Reference No. SMS1.20294-L28.Rev0

LOT 821 FRANCESCO WAY, ANGLE VALE – MIRAVALLE STAGE 1

T&J CONSTRUCTIONS
MIRAVALE STAGE 1
ANGLE VALE
SITE PLAN

POST-FILL LEVEL SURVEY MIRAVALE SOUTH, STAGE 1 ANGLE VALE	
DRAWING No.	SHEET 1 OF 1
20A0478.C0001 Miravale South Stage 1 Post Fill Rev 0	
REVISION	0

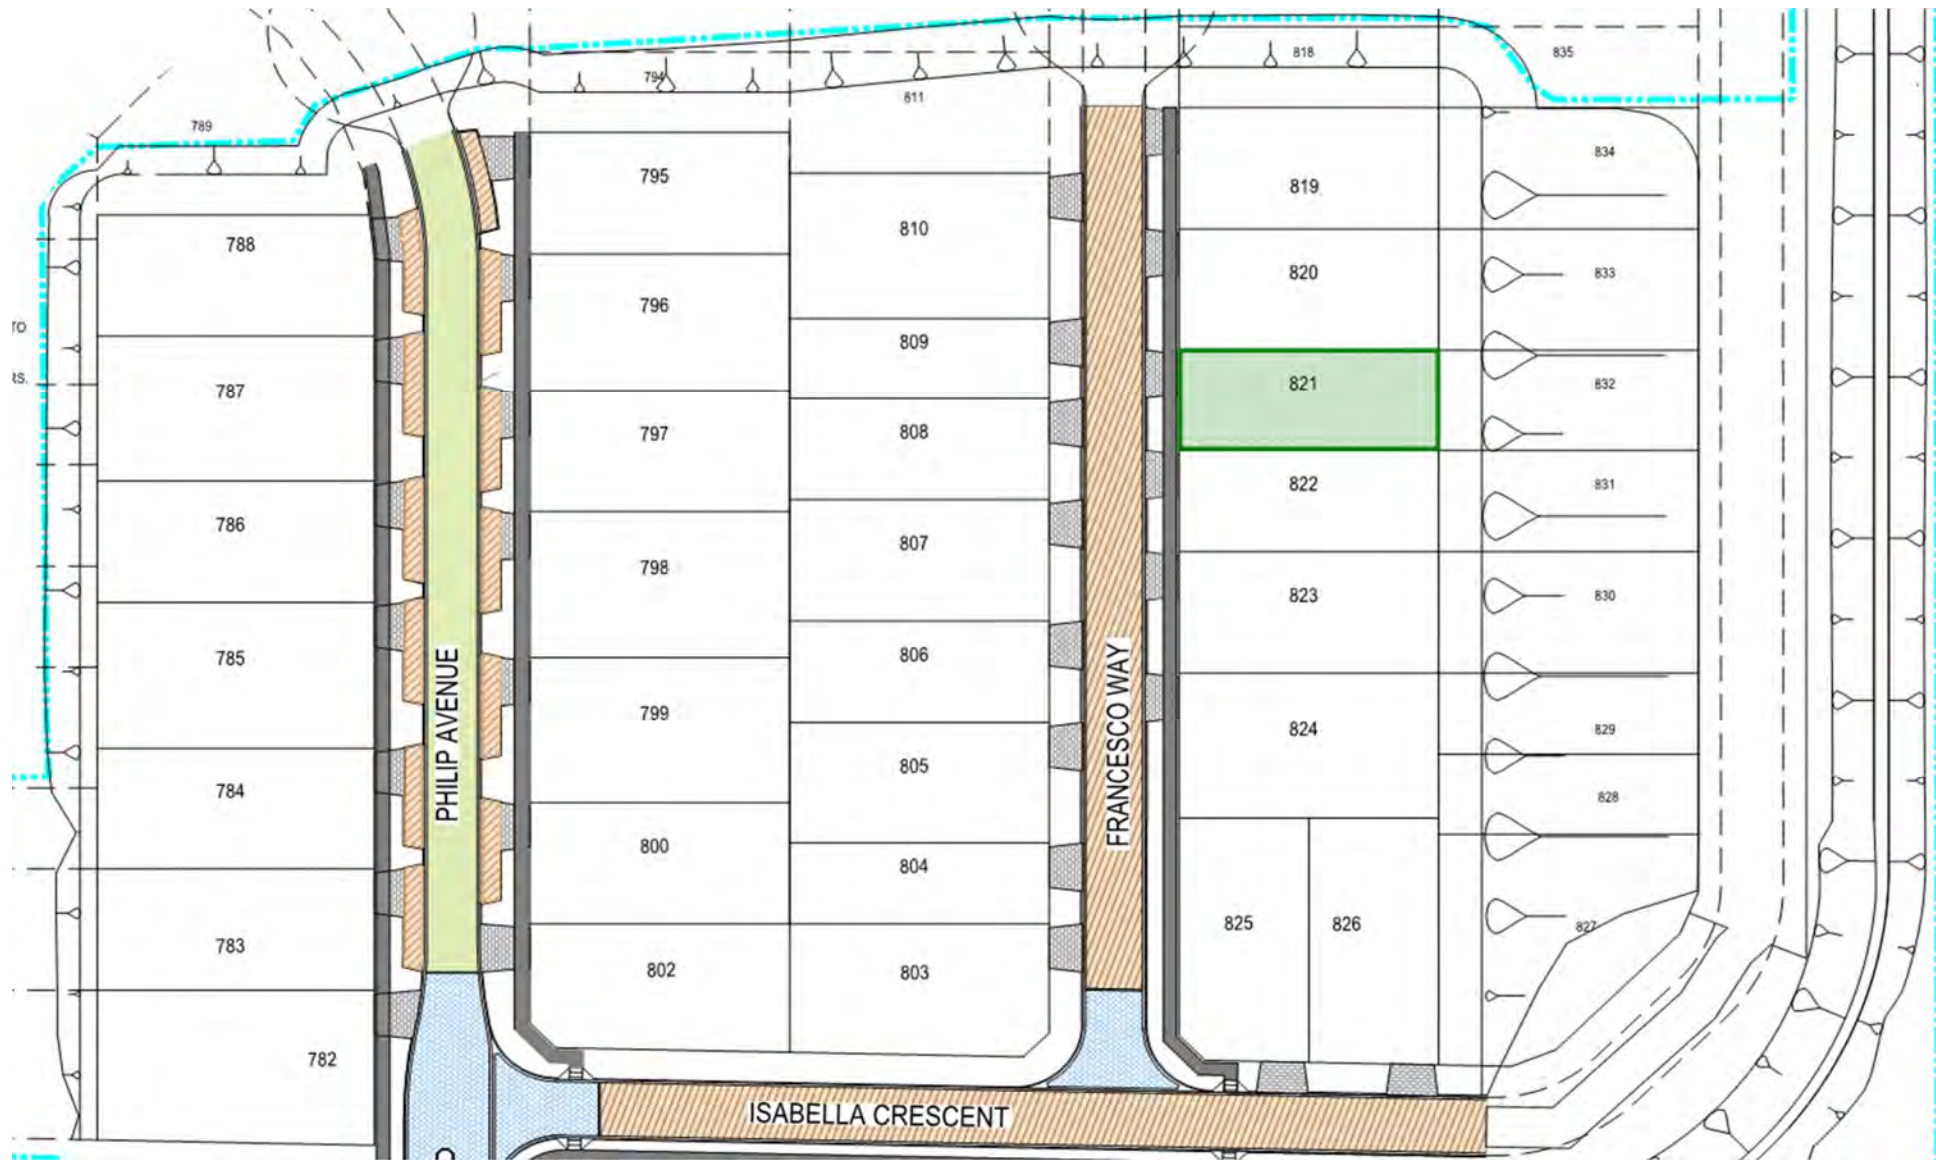
Project No.:	SMS1.20294	Drawing No.:	SMS1.20294-F28.Rev0
--------------	-------------------	--------------	----------------------------

SMS Geotechnical Pty Ltd (SMS) was commissioned by T&J Constructions to provide Level 1 earthworks inspection and testing services on Lot 821 Francesco Way, South Australia. The area where fill was placed is shown approximately in Drawing SMS1.20294-F28.Rev0.

On the completion of Level 1 earthworks inspection and testing, SMS advise that the fill placed on Lot 821 Francesco Way as shown in Drawing SMS1.20294-F28.Rev0, was witnessed and in our opinion meets the requirements of "Controlled Fill" as defined in AS3798-2007 and AS2870-2011 "Residential slabs and footings".

Approx. Fill Location
