Reference No. SMS1.20294-L37.Rev0

LOT 830 ISABELLA CRESCENT, ANGLE VALE – MIRAVALE STAGE 1

T&J CONSTRUCTIONS
MIRAVALE STAGE 1
ANGLE VALE
SITE PLAN

POST-FILL LEVEL SURVEY MIRAVALE SOUTH, STAGE 1 ANGLE VALE	
DRAWING No.	SHEET 1 OF 1
20A0478.C0001 Miravale South Stage 1 Post Fill Rev 0	
REVISION	0

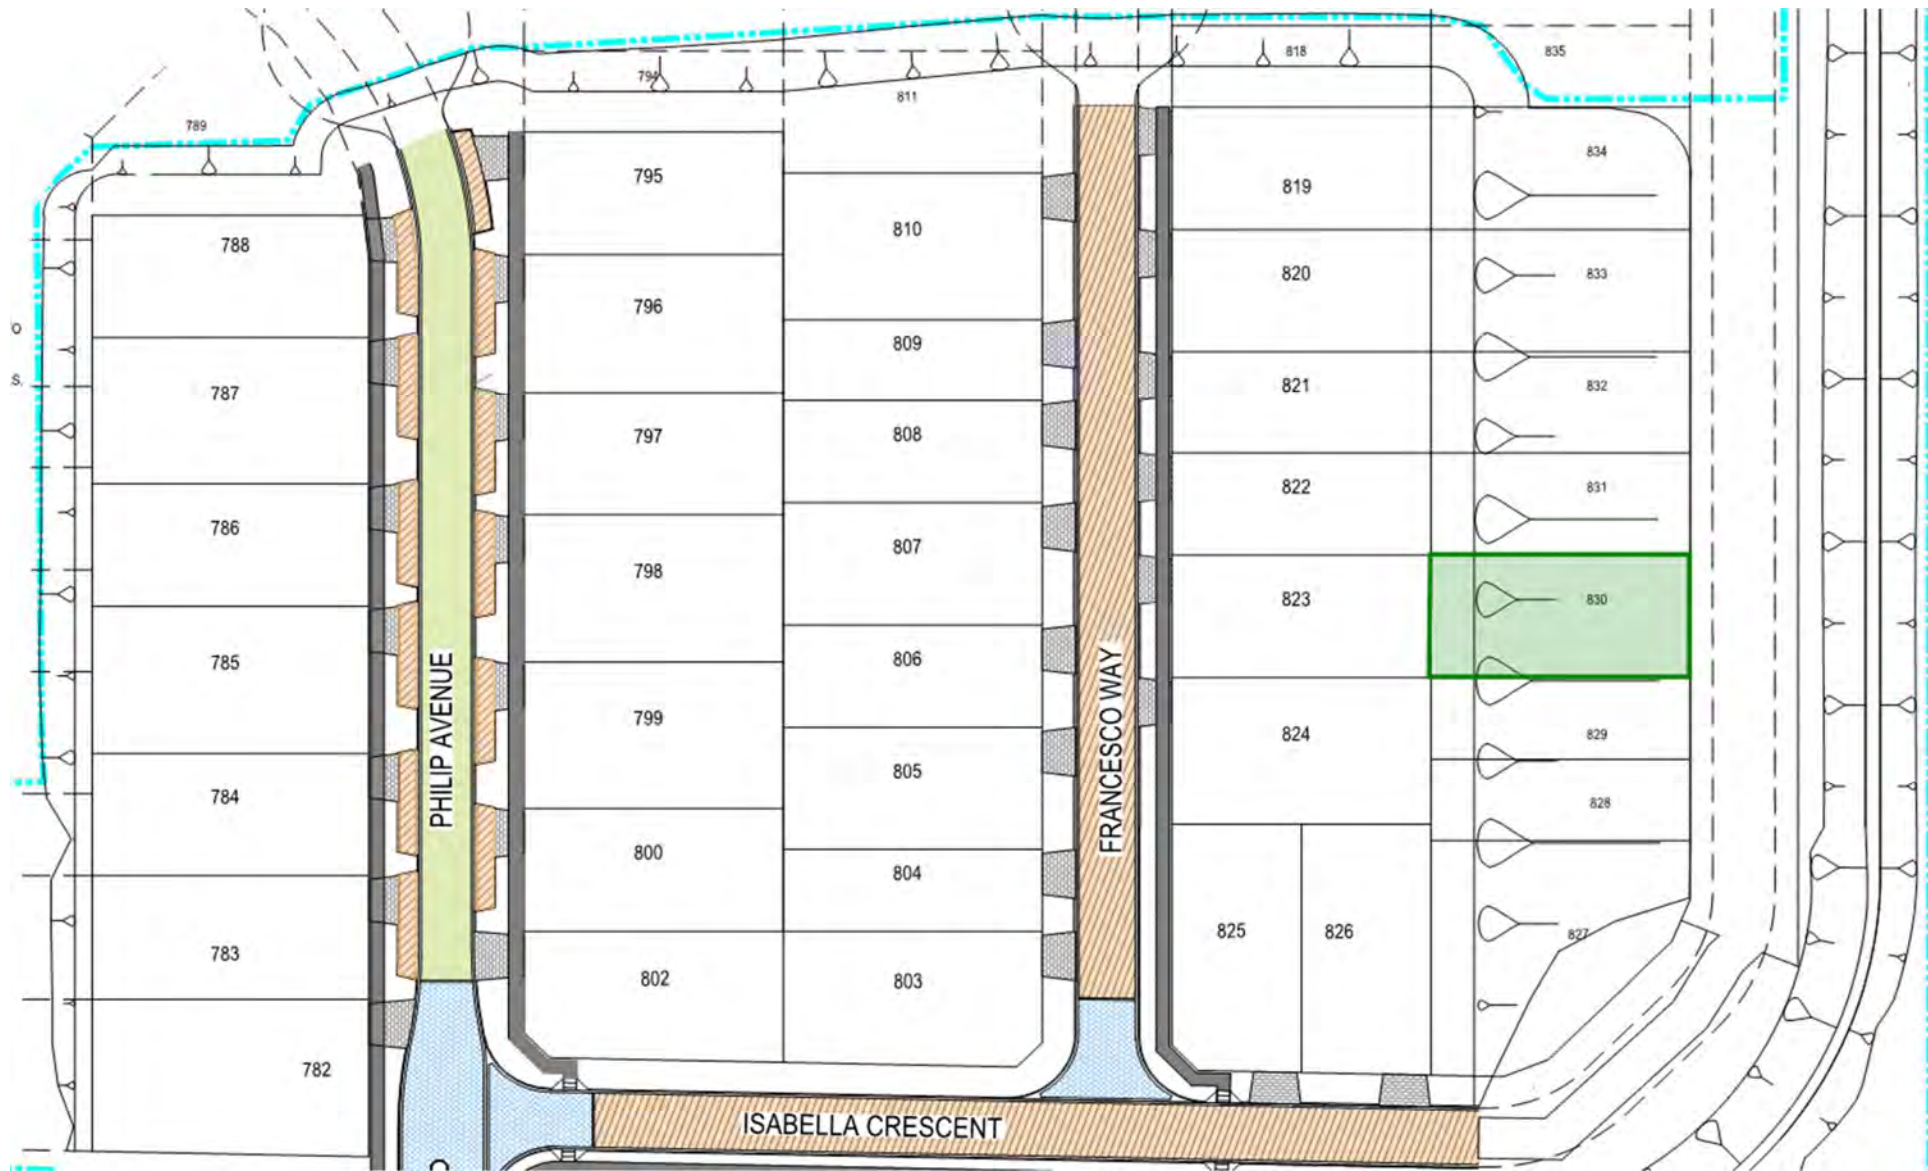
Project No.:	SMS1.20294	Drawing No.:	SMS1.20294-F37.Rev0
--------------	-------------------	--------------	----------------------------

SMS Geotechnical Pty Ltd (SMS) was commissioned by T&J Constructions to provide Level 1 earthworks inspection and testing services on Lot 830 Isabella Crescent, South Australia. The area where fill was placed is shown approximately in Drawing SMS1.20294-F37.Rev0.

On the completion of Level 1 earthworks inspection and testing, SMS advise that the fill placed on Lot 830 Isabella Crescent as shown in Drawing SMS1.20294-F37.Rev0, was witnessed and in our opinion meets the requirements of "Controlled Fill" as defined in AS3798-2007 and AS2870-2011 "Residential slabs and footings".

Approx. Fill Location
